## TOPIC 8: ELECTRICAL ACCIDENT INVESTIGATIONS – CASE STUDIES

### Case Study 1

**Refresher Course For Licensed Electrical Workers**

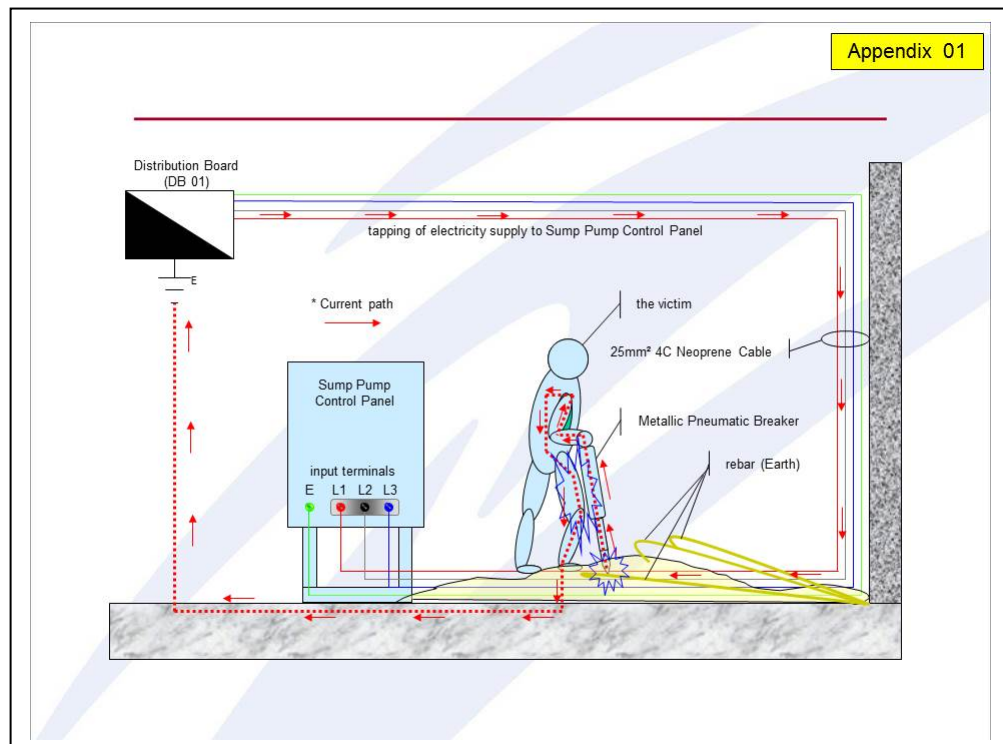
The underground work area was wet and damp, a 25mm<sup>2</sup> neoprene cable was found dangling from the wall and part of the cable was covered under the construction cement debris. The cable end was connected to the sump pump control panel (see Appendix 01). A metallic pneumatic breaker was found lying on the floor.

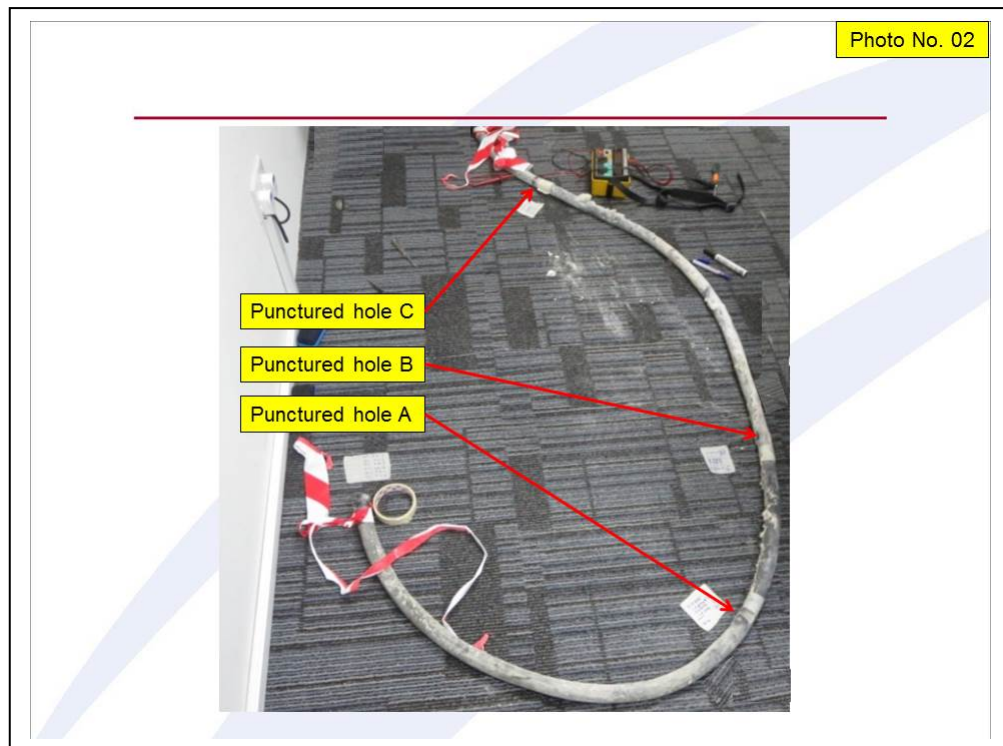
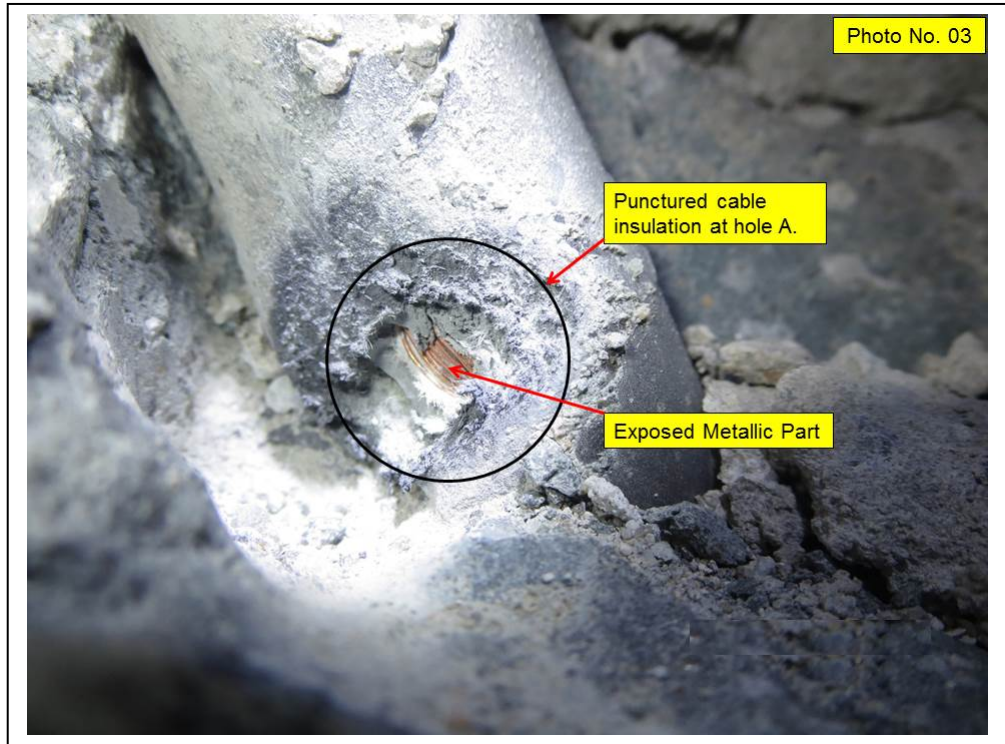
- a. There was three nos. of punctured holes on the neoprene cable and exposed metallic conductors could be seen as shown on Photos No. 02 & 03, labeled as punctured holes A, B and C;
- b. There was a dented mark on the surface of a rebar found nearby, it could be caused by the chisel of the pneumatic breaker when the victim was carrying out the work (see Photo No. 04).

It was possible that when the victim was using the pneumatic breaker for breaking the cement debris where the 'live' neoprene insulated cable was buried, the metallic chisel of the pneumatic breaker damaged the cable insulation and came into contact with one of the 'live' conductors of the neoprene cable. This would cause a current to flow from the exposed live cable cores through the metallic pneumatic breaker and the victim's body resulting in electrocution.

The accident could have been prevented if the 'live' cable and the control panel for the sump pump were decommissioned and removed before the commencement of construction work. Also, prior to the commencement of work, the cable should be checked using a voltage detector to confirm that it was not 'live' to ensure safety.

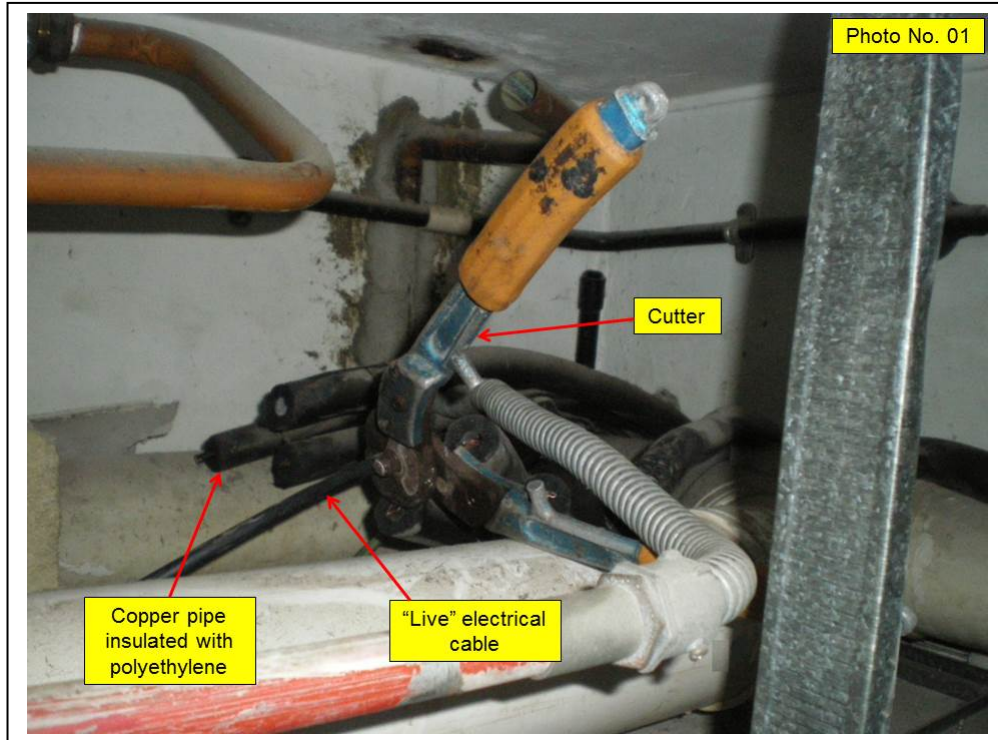
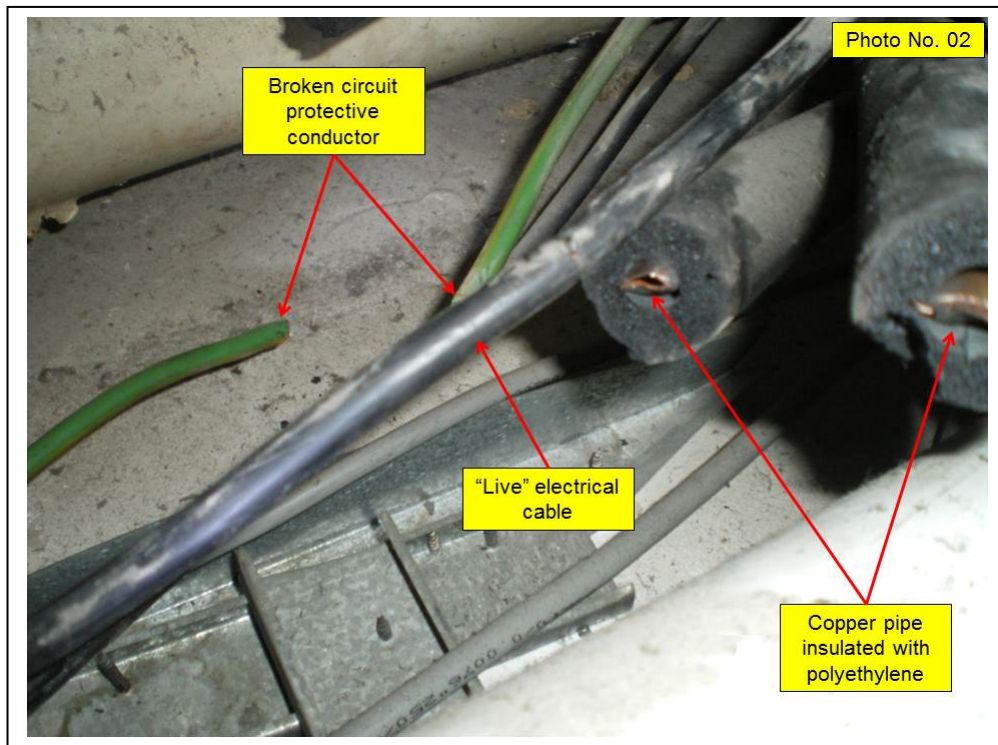
The cutter used by the victim was found with the metallic blades resting on a PVC insulated electrical cable. There was a few polyethylene insulated copper pipes and a green-yellow earth cable that had been cut in the vicinity of the cutter within the false ceiling. Voltage measurement between the metallic handle of the cutter in its original position and Earth was about 238V (see Photo No. 01 & Photo No. 02).

As the ceiling area was dark, the victim might have mistaken the 'live' sub-main cable as an insulated air-conditioning pipe that need to be removed.

The victim could have received an electric shock when the metallic cutter he was holding came into contact with the 'live' cable conductor at 238V (with respect to Earth), while part of his body was in contact with the earthed metallic pipes and other earthed metallic objects.

The accident could have been prevented if the victim or his supervisor had used a voltage detector to verify that all the cables and metallic objects in

the false ceiling were “dead” before proceeding to cut the air-conditioning pipes. Workers shall be advised that they should treat any cable ‘live’ unless they had checked and confirmed that the cable is not ‘live’ before commencement of work.
