BCA BE Seminar 2022
Buildings: What Can Go Wrong

Lessons Learnt from Structural Failures

Er Santoso Lukito

Building and Construction Authority

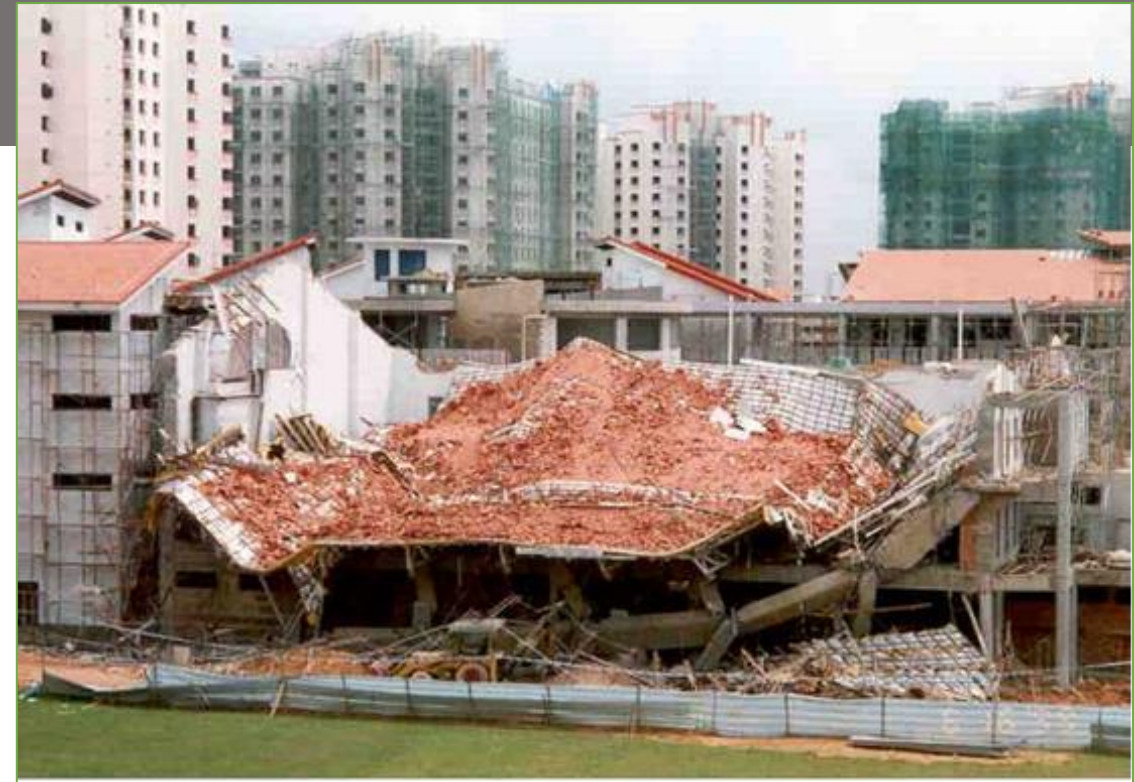
Multi-purpose hall roof collapse

4 storey multi-purpose hall with a pitched roof truss supported by RC column, spanning over 27m. The roof collapsed onto the 2nd storey while under construction.

- Inadequate design of the RC column support. Interactions of trusses with the supporting column were not considered.
- The joint support was assumed to be roller-support in the design while fixed bolted connection was provided on site. Outward horizontal forces arising from arching actions of inverted V-shaped truss were transmitted to the column.

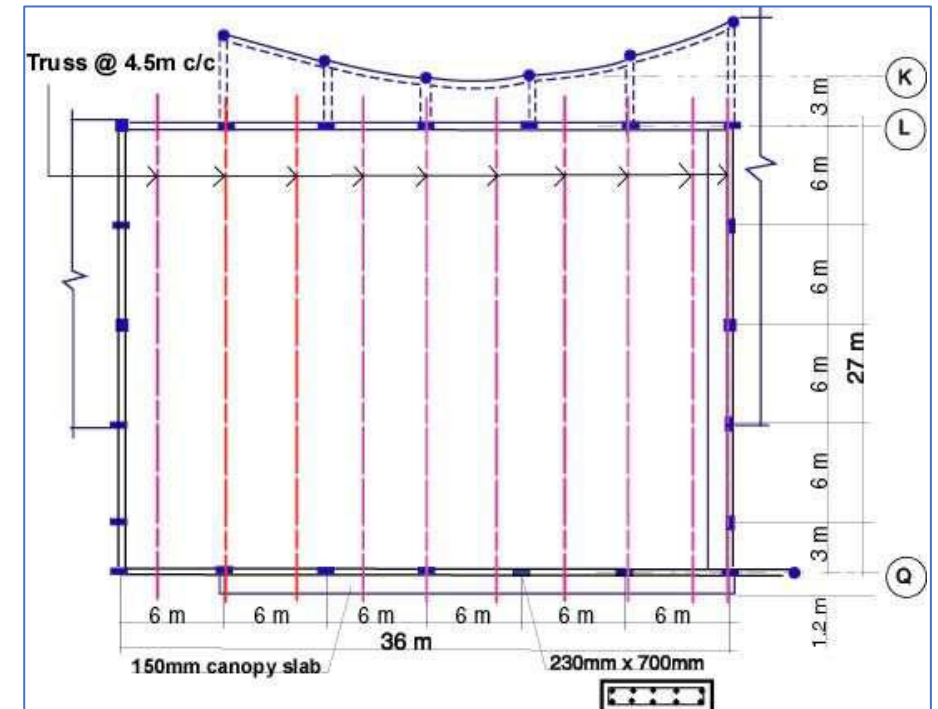
Multi-purpose hall roof collapse

- Column was orientated with weaker axes resisting the lateral thrust from the truss. Additional moment due to slenderness were also not considered in the design.

- Interactions of roof trusses with supporting columns and the orientation to resist the lateral thrust should be studied and analysed carefully.
- Connection details to be adequately provided in the drawing to prevent erroneous construction.

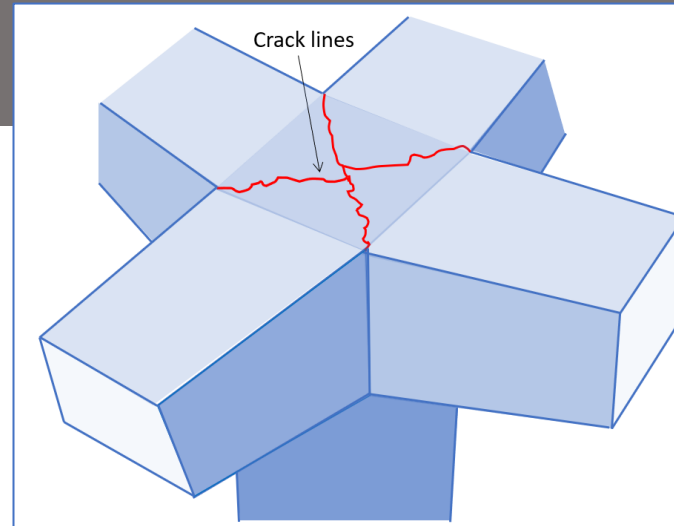
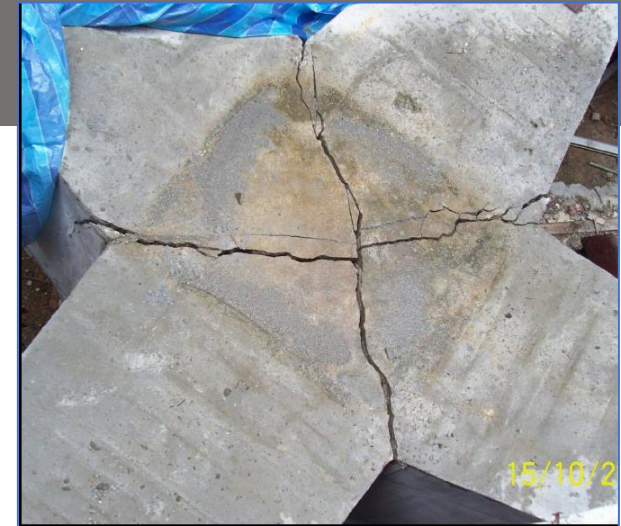
Cracks in tree-shaped column

Cracks observed on the column top, side and bearing support of multi-storey building during construction.

- Thick concrete cover, high stress concentration and ineffective transfer of anchorage force.
- Overlooked detailing issues. Omission of links in the upper part of column that provides restraining force to tie the top of column together so as to prevent the 4 inclined members to act as independent cantilevers.

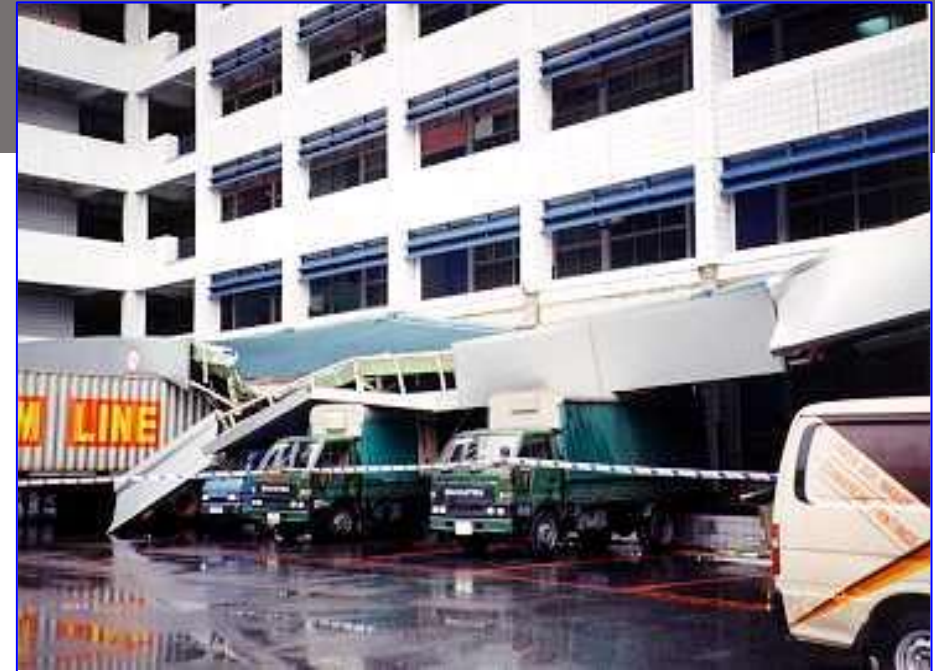
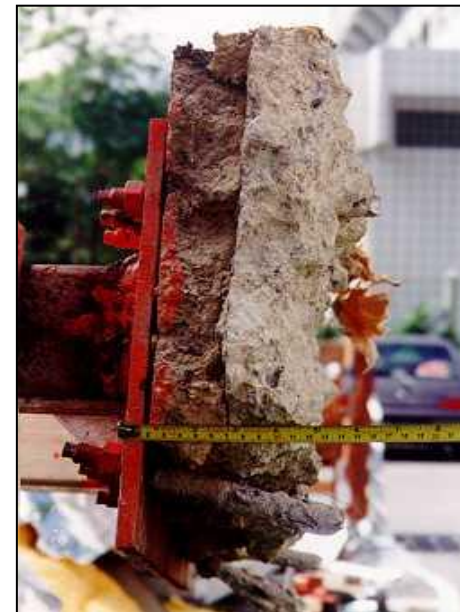
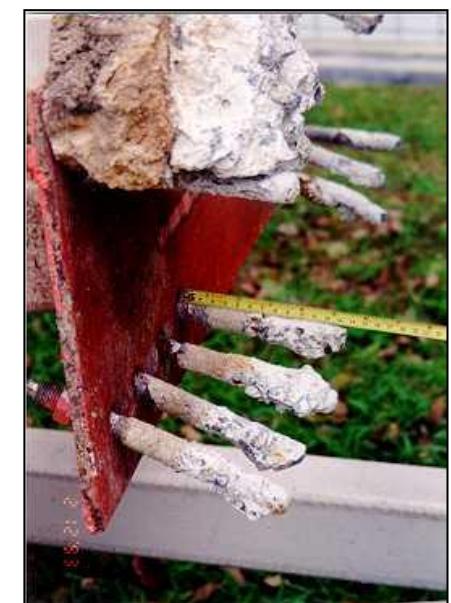
Post-installed anchor failure

Roof canopy supported by a series of 5m span cantilever trusses collapsed due to joint failure. The cantilever structure broke off from the existing building, debonding the anchors from the supporting RC member.

- Actual anchorage length observed was only half of what it was designed for. The anchors were mostly embedded in plaster.

- Inadequate embedment may result in significant reduction in shear and tension capacity of the anchors that eventually led to a failure at the connections.

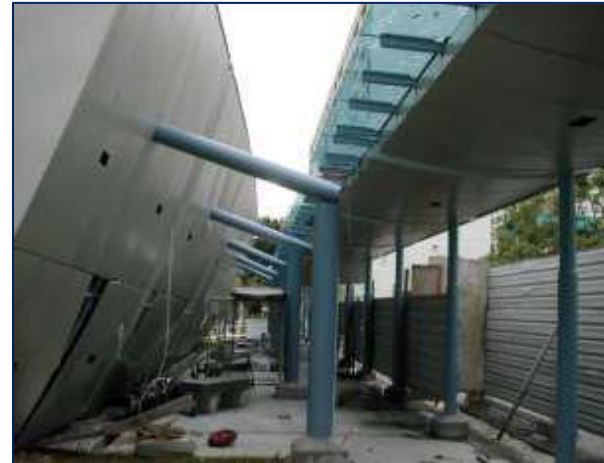
Cantilever member collapse

Cantilever steel canopy serving as a bus bay shelter collapsed at column joint.

- Splice plate was adopted to allow for different column size at lower and upper section. Fillet weld was carried out on site instead of the full penetration butt weld.

- Inadequate joint connection to resist the overturning force in the column may lead to failure.

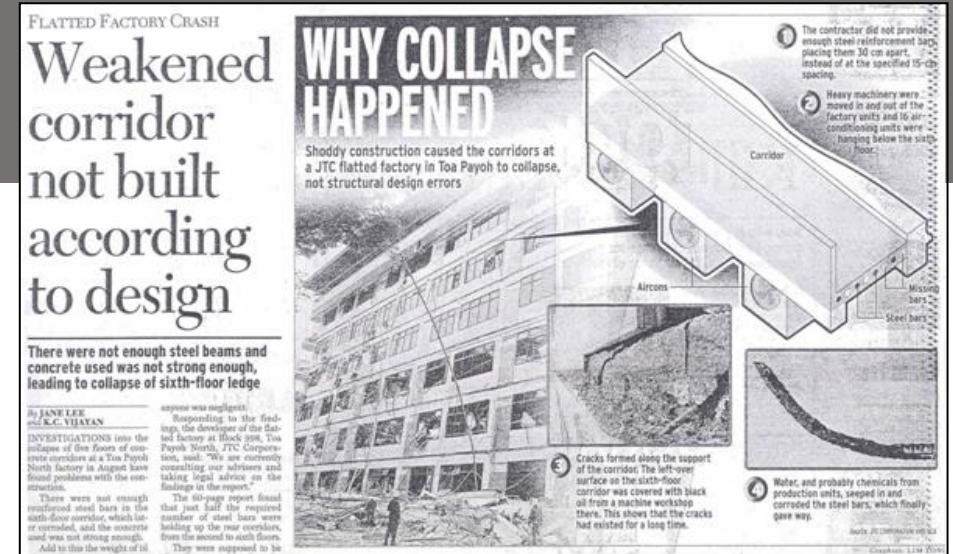
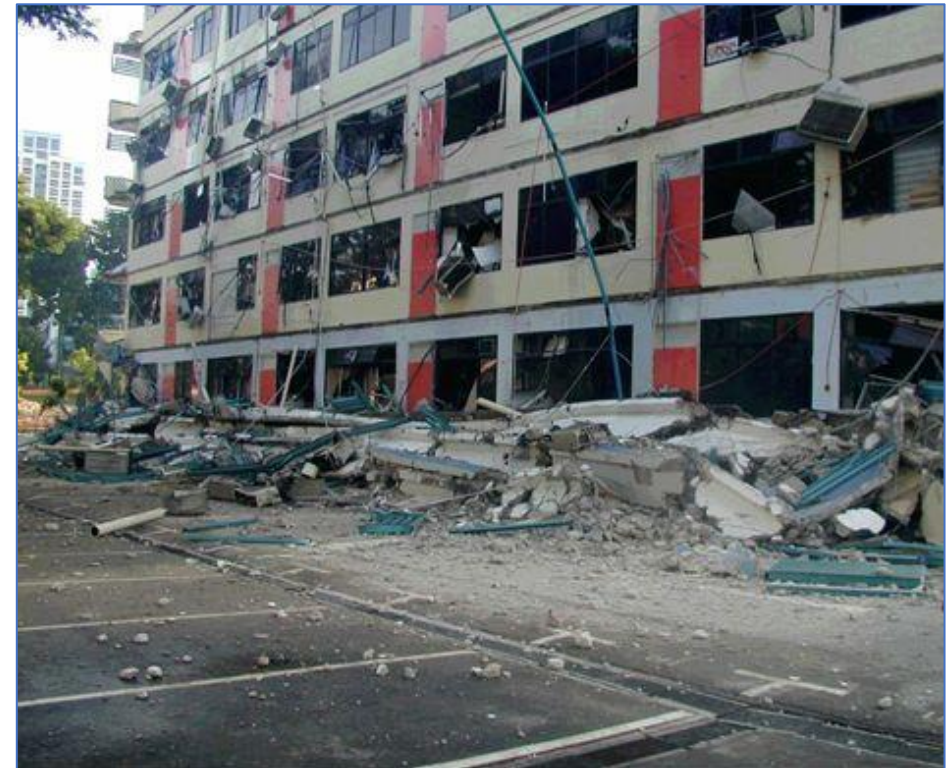
Cantilever member collapse

6th storey cantilever concrete slab collapsed and triggered progressive collapse of the 2nd to 5th storey corridor slab.

- Inadequate provision of bars observed. Reinforcement 50% less than shown in the drawings.
- Lack of inspection where the rebar rust due to water seepage along the corridor. Sign of corrosion further weakened the cantilevered slab.

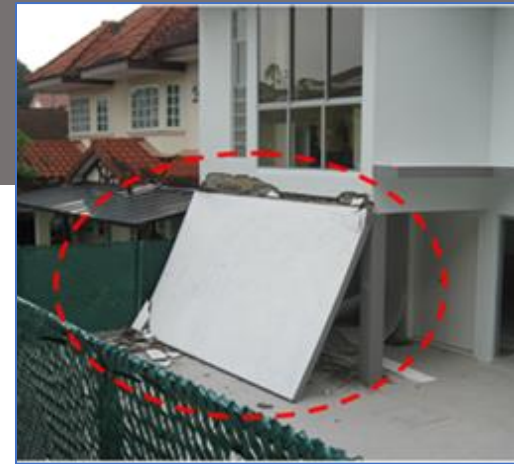
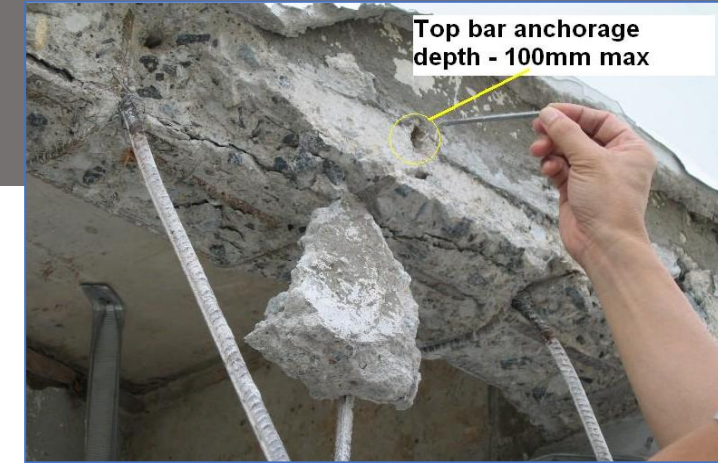
Cantilever member collapse

3m long cantilever car porch canopy slab of a 2 storey semi-detached house collapsed. The canopy slab failed at the joint to the supporting 2nd storey beam.

- Mainly due to insufficient rebar anchorage of canopy slab into the supporting beam, which is critical in providing the necessary tension capacity for the cantilever car porch.
- Instead of full anchorage with rebar bent 90 degrees vertically into the supporting beam, the rebar was found to be horizontally anchored into the supporting beam.

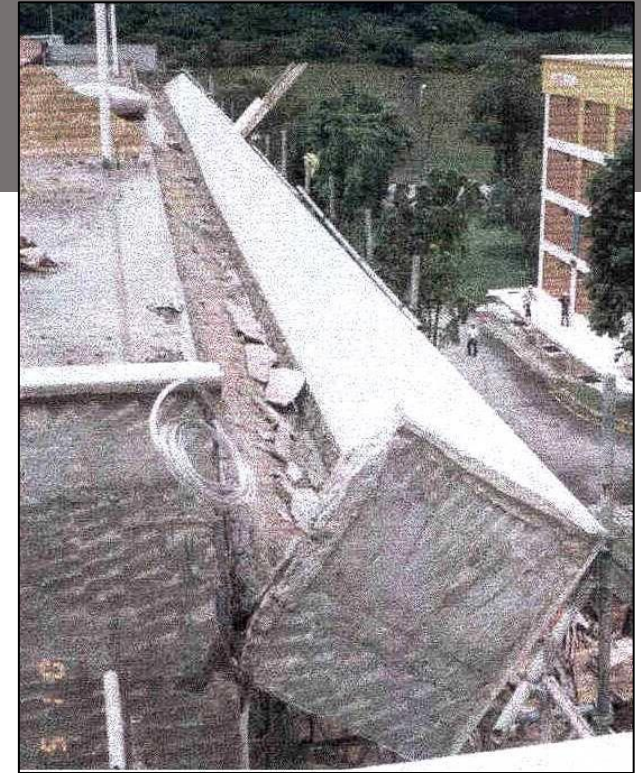
Cantilever member collapse

RC gutter detached partially from the roof of 4 storey school after structural work completion.

- Inadequate tension reinforcement for additional imposed load when the gutter was filled with water. No design calculation of the gutter.

- Importance of site supervision and reinforcement detailing, especially in cantilever member where the tension rebar has to be adequately anchored into supporting member to provide the necessary bending moment resistance.

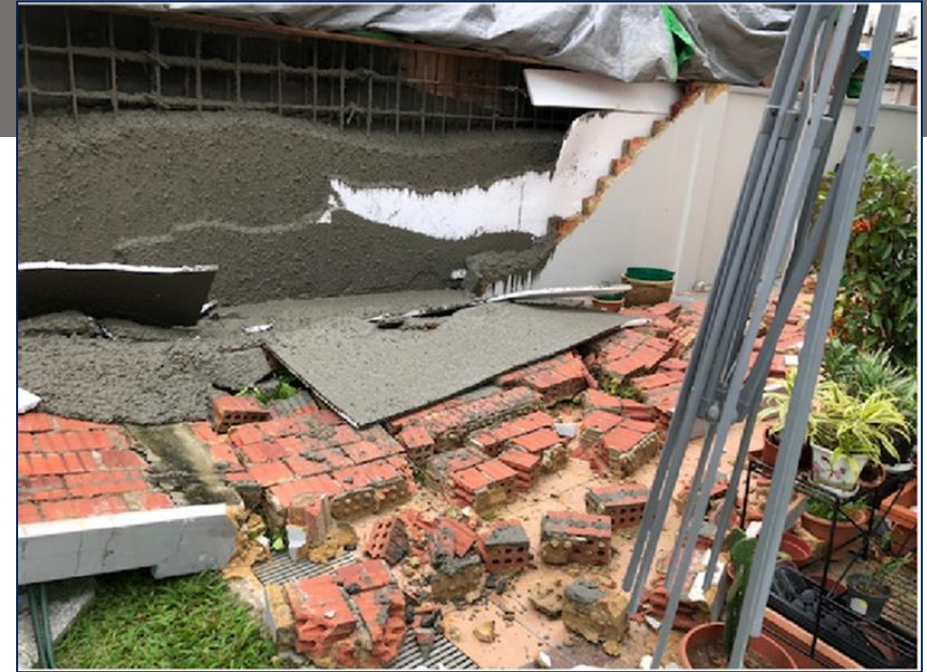
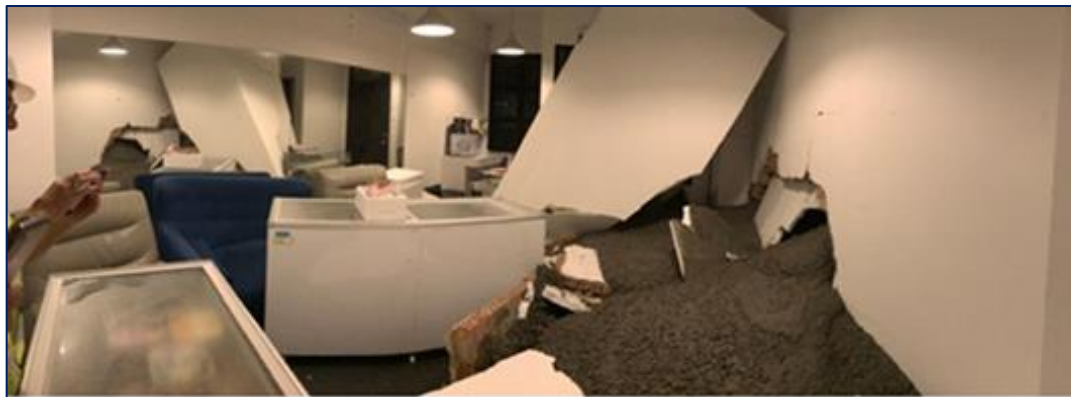
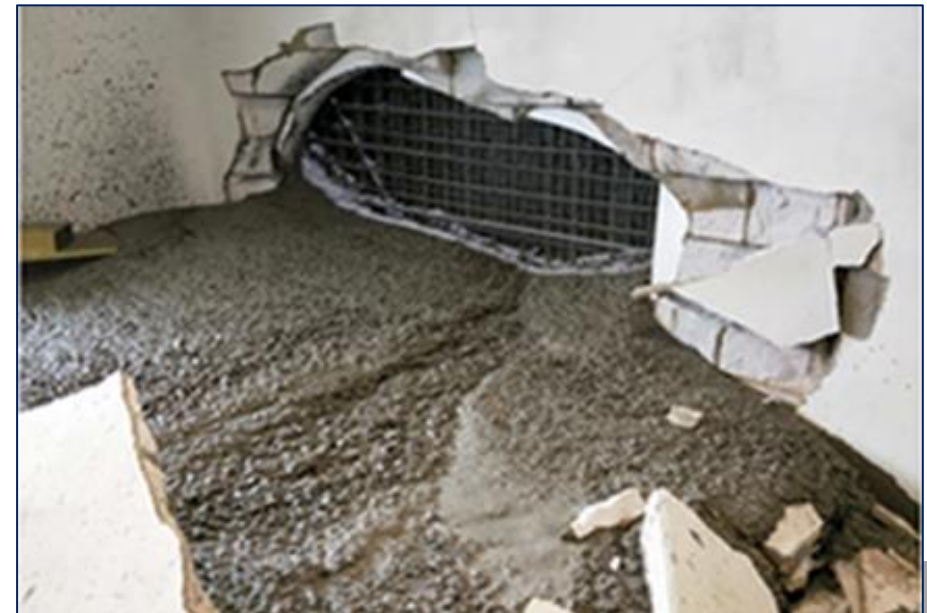
Party wall collapse

There were a number of incidents involving the collapse of party wall. The shared party wall between houses made of brick was not designed to resist any lateral forces.

- Incidents typically occurred during concreting of the proposed RC wall that abuts the existing party wall. Hydrostatic pressure from wet concrete exerted lateral force on the party wall that may cause collapse.

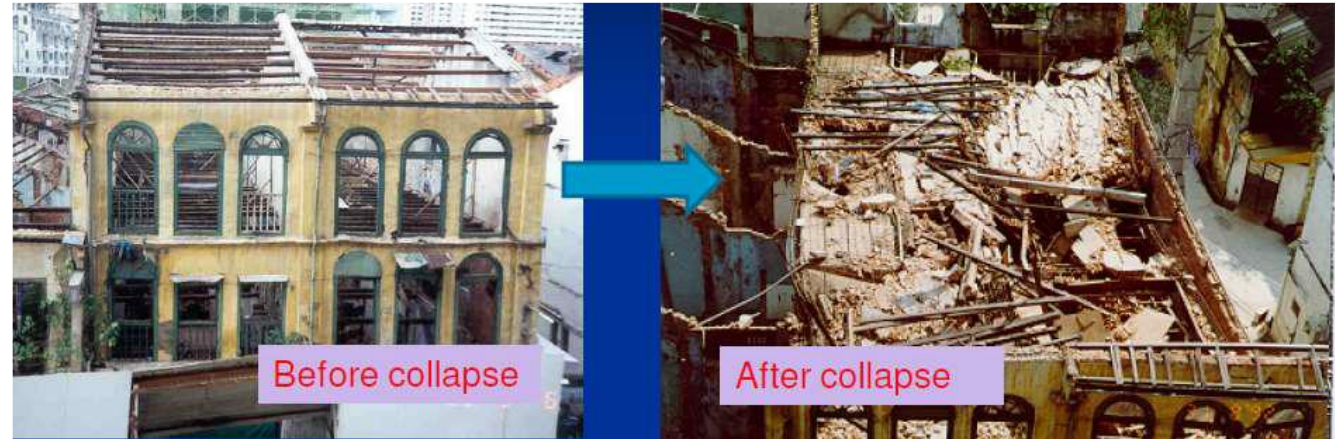
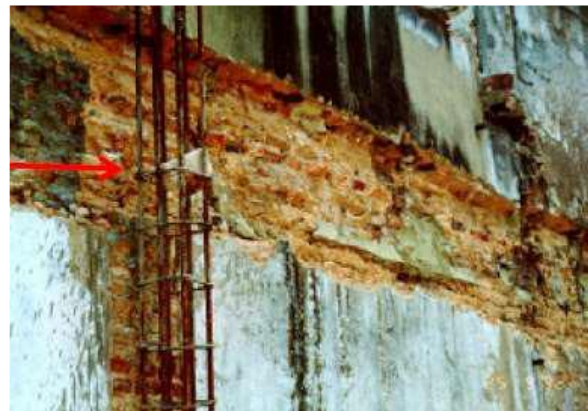
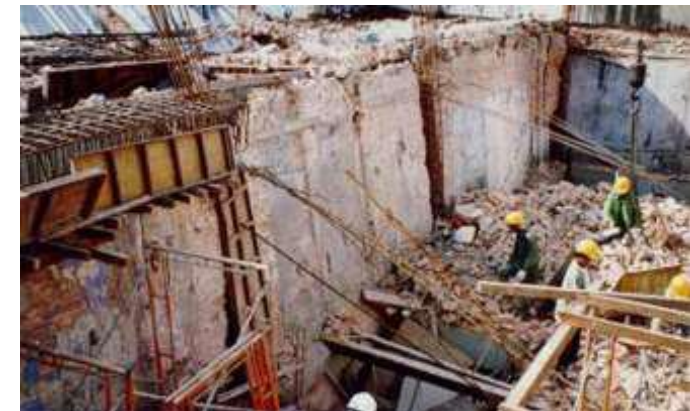
Party wall collapse

3-storey shophouse collapsed due to hacking of existing party wall to partially embed new columns and beams.

- The common party wall was weakened as a result of chasing of the existing party wall.
- The timber floor joists were also removed without any temporary bracings added, further compromising the overall stability of party wall.
